Peri-Implant Fracture in an Operated Case of Left Sided Radius Ulna Shaft

Fracture with Volar Plate - A Case Report and Review of Literature

Dr Neetin Mahajan, Jayesh Mhatre*, Dr. Pravin Sarkunde

Department of orthopedics, Grant govt medical college, India

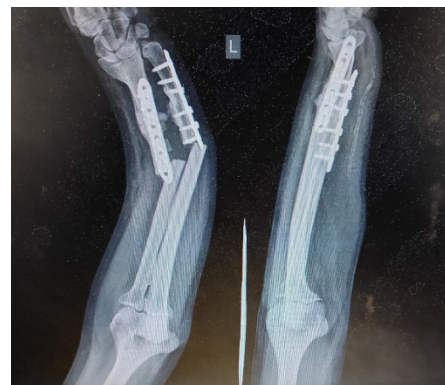
Figure 1

At the physical examination the forearm dorsal Angulation showed deformity. The patient was unable to actively move his forearm, with aggressive pain at passive movements. No vascular or neurological deficiencies were found. An X-ray examination revealed a peri-implant fracture of the radius and ulna shaft just below plate the plate was still affixed to shaft of radius and ulna (Figure 1). The following this, the patient was surgically treated. A modified henrys approach for radius shaft and subcutaneous approach for ulnar shaft was performed with a skin incision placed over the previous surgical scar. The plate and screws were removed, and the reduction was performed. Internal fixation was performed using a 3.5 mm dcp for both radius ulna shaft. Reduction maintenance and articular alignment were restored. The x-rays images after the procedure showed a good reduction of the fractures (Figure 2a). Postoperatively, the forearm was splinted for 10 days. After removing the stiches, the patient started rehabilitation to improve the range of motion in the forearm and wrist, using active and gentle active-assisted exercises. Clinical and radiological (Figure 3a) follow-up was scheduled at 1, 3 and 6 months. At the

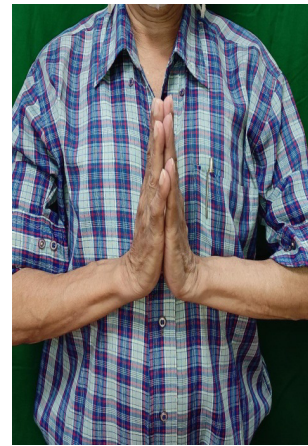
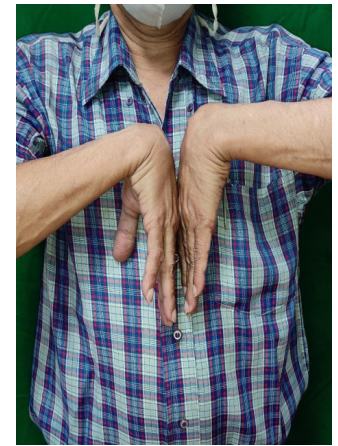
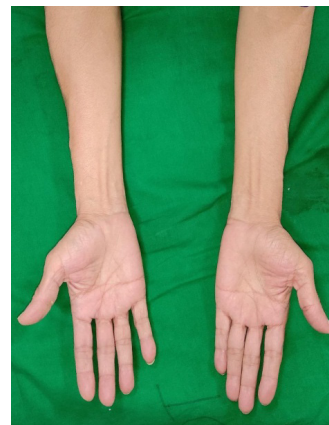
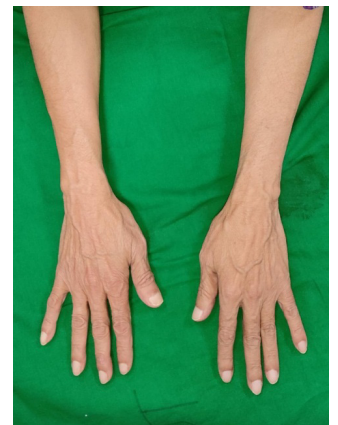
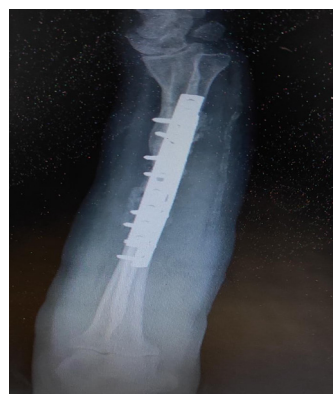
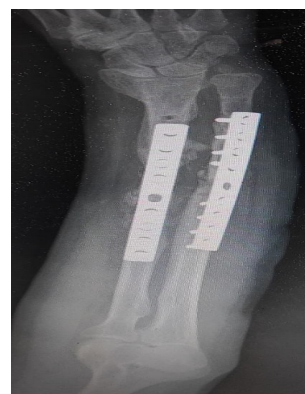
Figure 3A

30-day follow-up, the ROM was 25° of dorsiflexion, 30° of palmar flexion, 45° of pronation and supination.
