Intra-Abdominal Migration of an Osteosynthesis Pin Causing Bladder and Vascular Injury: A Rare Case Report

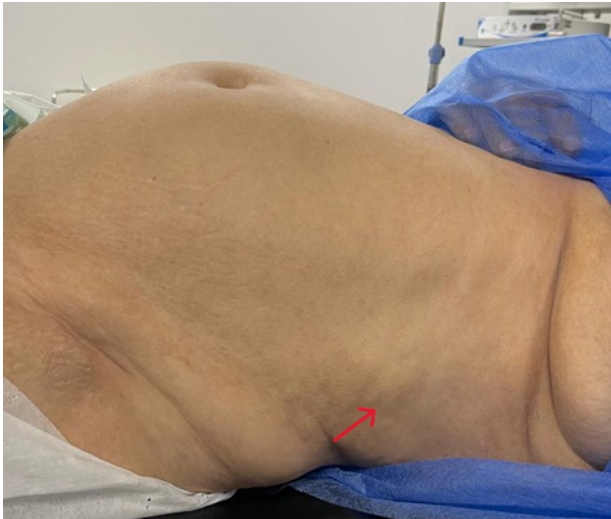
Figure 1: Image showing the subcutaneous prominence of the osteosynthesis pin.

Clinical examination revealed a conscious patient who was hemodynamically and respiratorily stable. Abdominal examination showed a distended and tympanic abdomen, with palpable osteosynthesis material in the left hypochondrium.

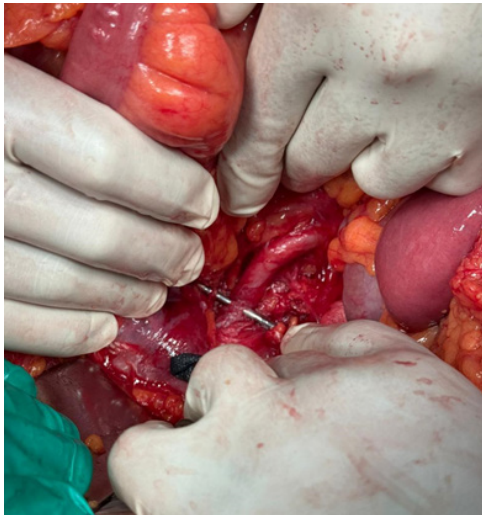
Figure 4: Intraoperative view showing vascular injury of the left common iliac artery caused by the migrated pin.

The pin then followed a retroperitoneal course through the sigmoid mesentery and perforated the left common iliac artery while sparing the left iliac vein and the left ureter.

The surgical procedure consisted of extraction of the intra-abdominal migrating pin, repair of two lacerations of the left common iliac artery, closure of the bladder perforation, and drainage of the Douglas pouch using a Salem sump drain.
