## **The Use of Operating Microscope for Removal of Broken Instruments from the Canal in Endodontic Treatment**

**Purpose:** To evaluate the success of using an operating microscope to remove broken instruments from different levels in curved and straight canals.

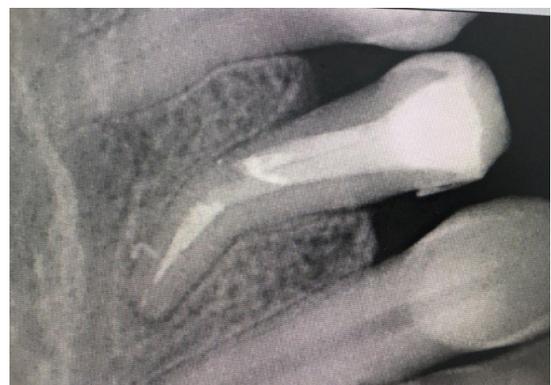
*Figure 1: Rentgen picters fractured endodontic instruments in root canal.*

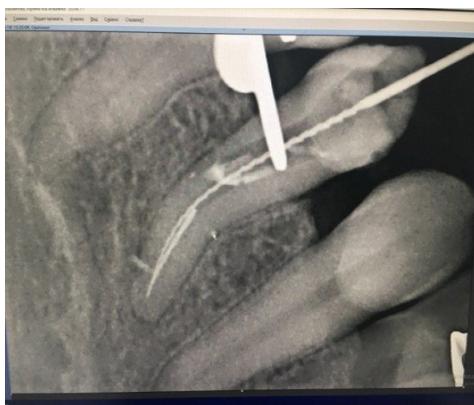
*Figure 2: Rentgen pictures remove fractured endodontic instruments in root canal.*

An ultrasonic tip # 3 and 4 (pro ultra) was used at power 4. It was placed between the open part of the file and the canal wall and activated in a counterclockwise direction to remove dentin around the separated file.

After loosening the broken instrument from the curved canals, it was caught and removed using special pliers with fine toothed branches. After the broken was removed, we proceeded to the next stage - removal of the residual cement and paste in the coronal part of the root canal with an ultrasonic tip. The sealant was removed from the mid- and apical root canal using Pro-Taper D1-D3 endo-denture rotary instruments. After ensuring the patency of the root canals (the second canal was detected palatally), the following procedure followed - mechanical and chemical cleaning and the formation of the root canal. Used Crown Down technology and K3 rotary nickel-titanium files. 3% H<sub>2</sub>O<sub>2</sub> and 2.5% sodium hypochlorite were used for short term treatments. A 17% EDTA solution was used to remove the smear applied to the root canal for 1 min. After removal of the instrument, the tooth canal was filled and the tooth was filled.

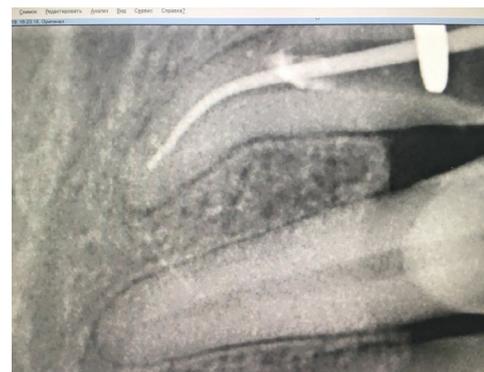
*Figure 3: After removal of the instrument, the tooth canal was filled and the tooth was filled.*

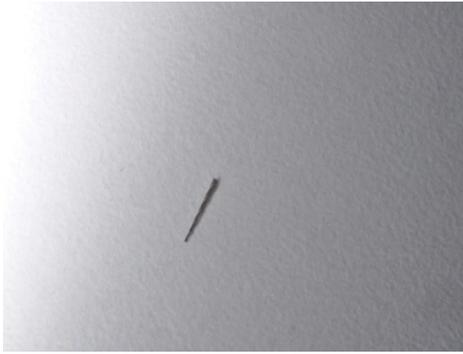
*Figure 4: Fractured Endodontic Instruments from Root Canal Systems.*
